TRANSCON Review		Marriott Courtyard Sailisbury , NC		Panel29-34			
STEEL		Drawn by	Scale	Date	Size	Project number	Drawing number
FRAMING THE FUTURE			As indicated	07/12/12	Α	12-105	2.13

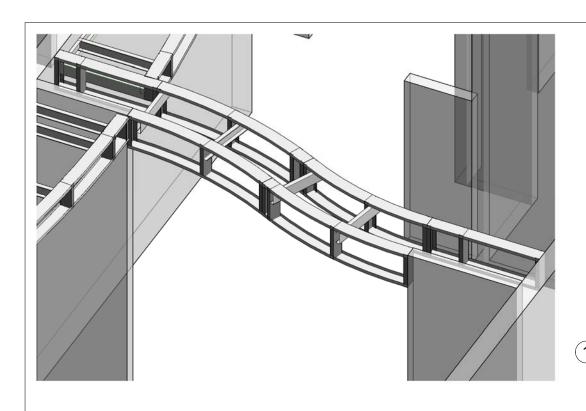
3 Panel 29 1/2" = 1'-0"

> Lbl Qty Member Length C0 3 362S125-18 11 3/8"

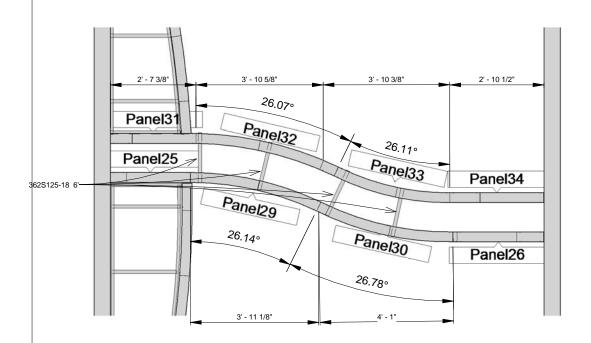
5 Panel 32 1/2" = 1'-0"

Lbl Qty Member Length C0 4 362S125-18 11 3/8" T0 2 362T100-18 4' - 5 1/4"
